Fire experiment to examine the use  
of ultra high pressure extinguishing  
systems for fires in batteries of  
electric vehicles

Authors	T. Hessels and H. Brans
Contact person	T. Hessels
Client	The Netherlands Fire Service / Haaglanden Safety Region
Contact person	W. Muysson / R. Turkenburg
Date	26 November 2024
Photos:	NIPV, unless stated otherwise

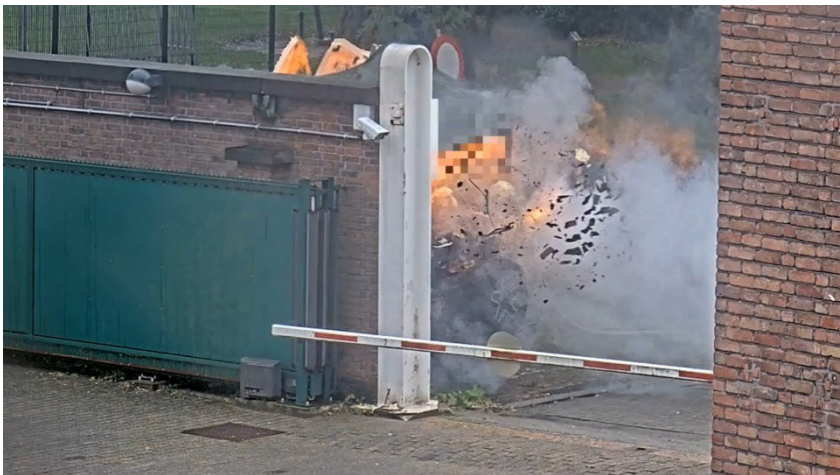
**Figure 2.3 Explosive ignition of a vapour cloud (photo: unknown)**

If the flammable gases accumulate they might explode. This can happen in particular if the vehicle is parked indoors or under a carport or if the gases accumulate in the closed passenger compartment of a vehicle (Vos et al., 2024). The flammable gas cloud can ignite under certain conditions. This is known as delayed ignition.

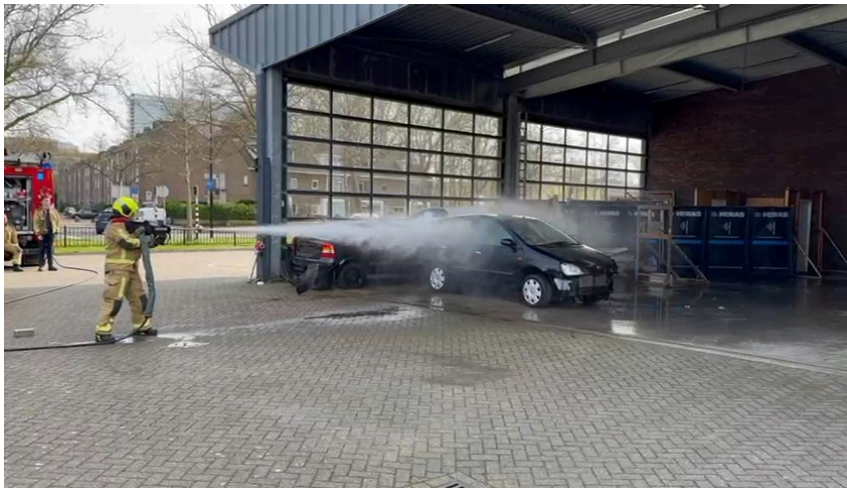
**Figure 4.5 Deployment of UHP extinguishing system to bust the windows (photo: Haaglanden Safety Region)**

The Safety Region conducted a sub-experiment with an end-of-life vehicle and found that it is possible to use a water jet to bust the windows from a distance of seven metres. It was also established that it is possible to bust the windows on both sides of the car by deploying a water jet to one side of the car. To do this, the jet is directed through the vehicle from the same position. Of course, no one should be in the area covered by the water jet of the UHP extinguishing system. The removal of gases from the vehicle can be accelerated by means of a fan.

As discussed in section 3.3, no advice for action is known that relates to the scenario of a closed passenger compartment where there may be a risk of explosion due to flammable gases that could accumulate. The Haaglanden Safety Region has a suggestion for this, which is to use a high pressure water jet to bust the windows of the vehicle from an ample distance. If water that contains abrasive is used, the UHP extinguishing system can do this. This will cause the windows to crack, enabling the flammable gases to exit the vehicle. The high impulse of the jet water will also drastically accelerate the venting of the gases. It is important that an ample distance is kept here; see Figure 4.5.

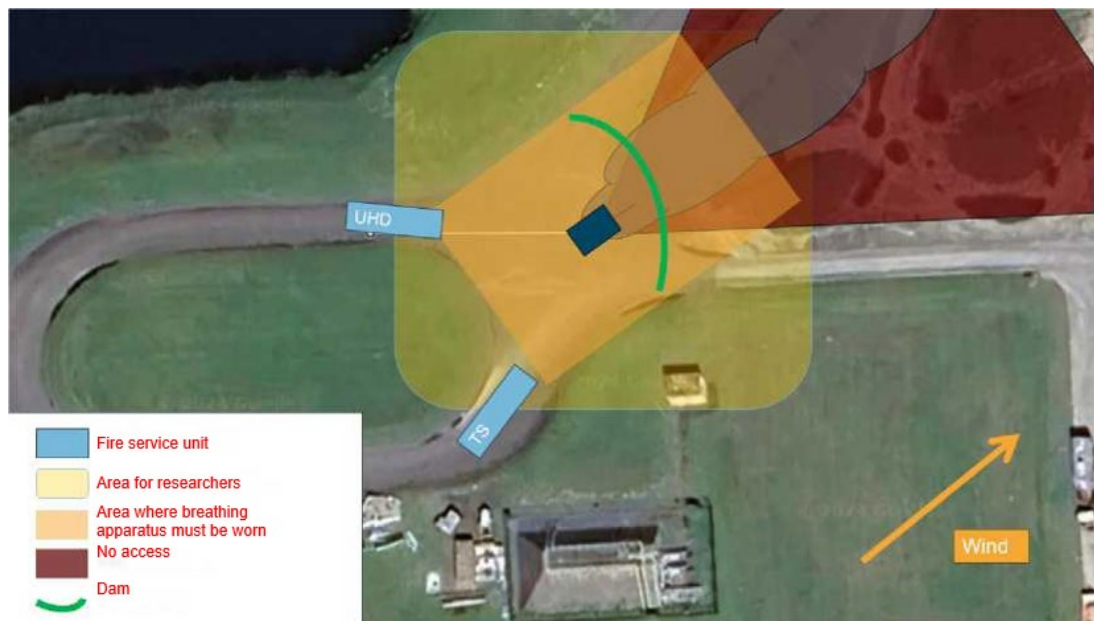
Figure 4.7 Site layout

The blue areas show the location of the UHP unit and the FA. The yellow area was where the researchers worked. Breathing apparatus had to be worn in the orange area. No access was allowed to the red area during the experiments due to toxic gases and smoke. The curved green line shows the location of the extinguishing water dam, and the orange arrow indicates the prevailing wind direction that day.

Figure 4.7 shows the general layout of the location.

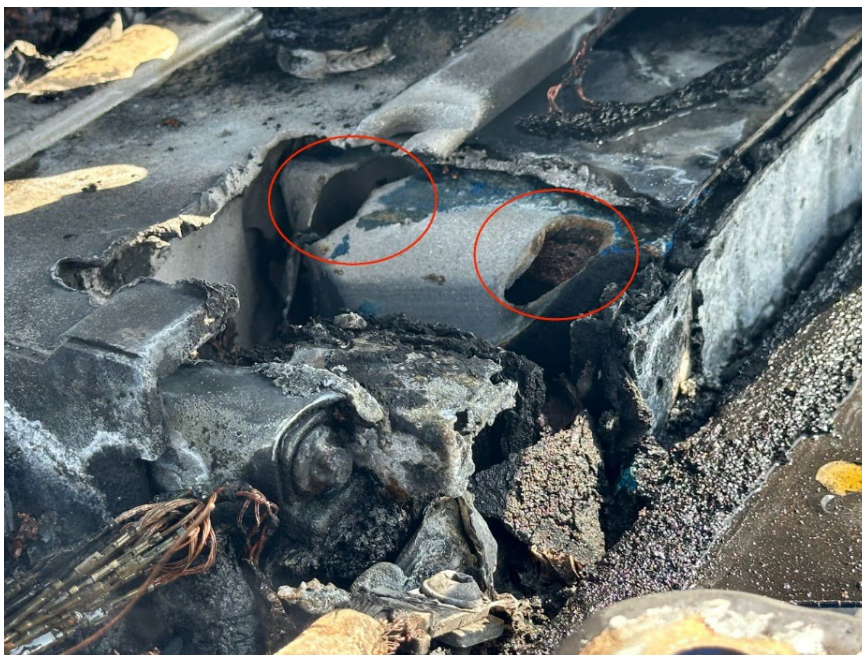
**Figure 5.3** Damage or holes after deployment of the UHP extinguishing system

It was discussed in section 3.1.5 that it is possible that the UHP extinguishing system damages battery cells, causing them to go into thermal runaway. An example of such damage in the battery of the experiment is shown in Figure 5.3, where the slanting entry of the extinguishing agent with abrasive can be seen. It is not known whether this damage caused these cells to go into thermal runaway. Figure 5.4 has red circles indicating the locations of the holes cut by the UHP extinguishing system.

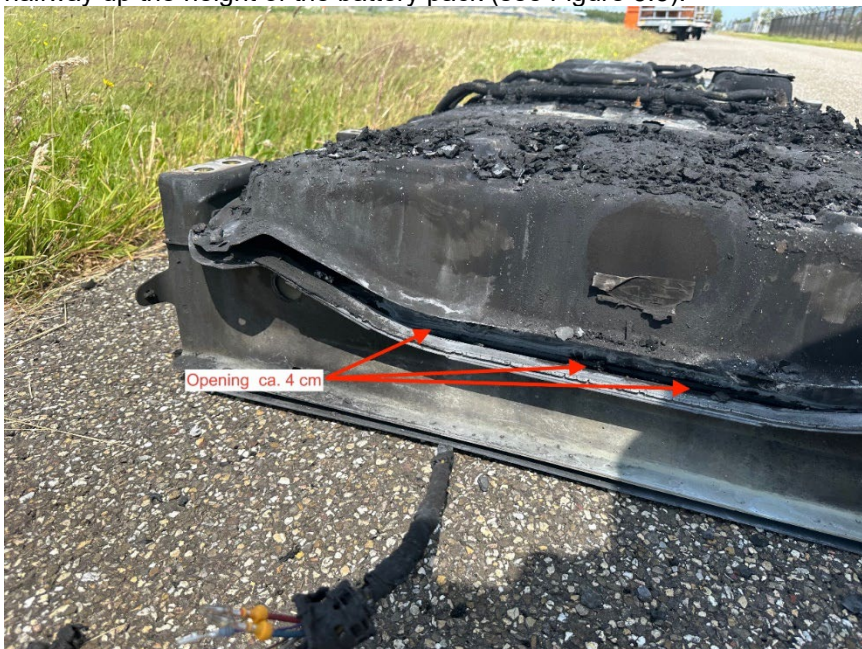
**Figure 5.5 Opening of battery pack by overpressure**

Furthermore, the top of the battery pack came loose from the bottom during the experiment. This is because the heat caused the adhesive between the top and bottom to come loose in some places. The overpressure created by gases from the thermal runaway detached the top from the bottom in some places. This created several openings of about four centimetres halfway up the height of the battery pack (see Figure 5.5).

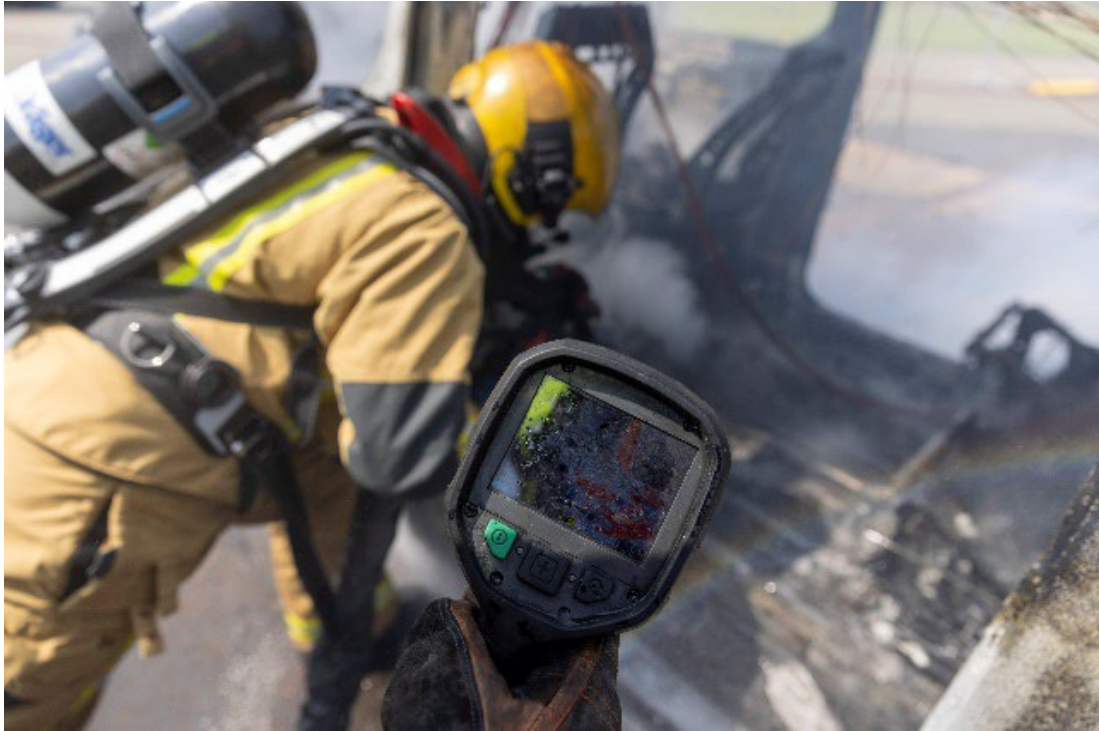
**Figure 5.6 Locating hot spots using a thermal imaging camera**

The same procedure was followed during the second deployment. Hot spots were located with the TIC and then penetrated with the UHP extinguishing system (Figure 5.6). Flames coming from the battery pack were repeatedly observed during this procedure (Figure 5.7). Because of this, a jet was continuously deployed to extinguish these flames and a second jet was deployed as a backup for the first jet in order to be able to extinguish the flames from a different angle. The extinguishing of these flames is shown in 5.8. The optimum location for the UHP deployment, as close to the hot spot as possible, was difficult to reach because of the flames from the battery pack. A low-pressure jet was therefore deployed to create a safe workplace for the staff of the UHP unit. The UHP extinguishing system was deployed to several different hot spots until no more hot spots were observed.

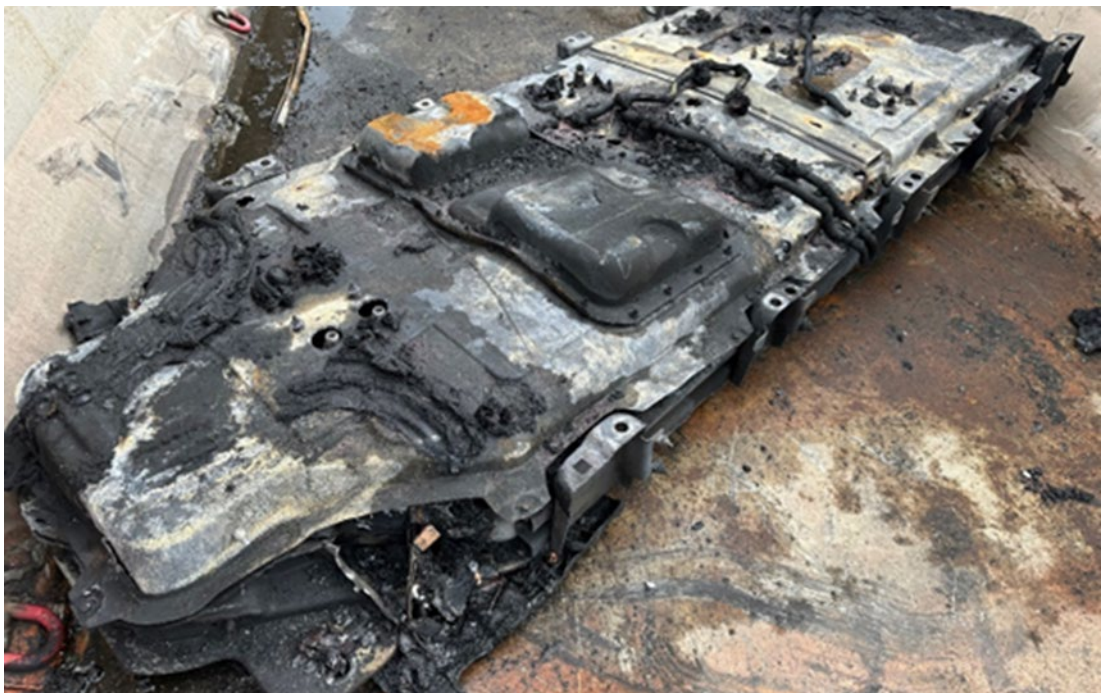
### Figure 5.9 Battery of the second fire trial

This experiment also involved removing the battery pack from under the vehicle after the experiment in order to study it and for easy disposal to a recycling company. After removing the battery pack from the vehicle it was set aside in a dry submerging container for closer inspection. This battery is shown in Figure 5.9.

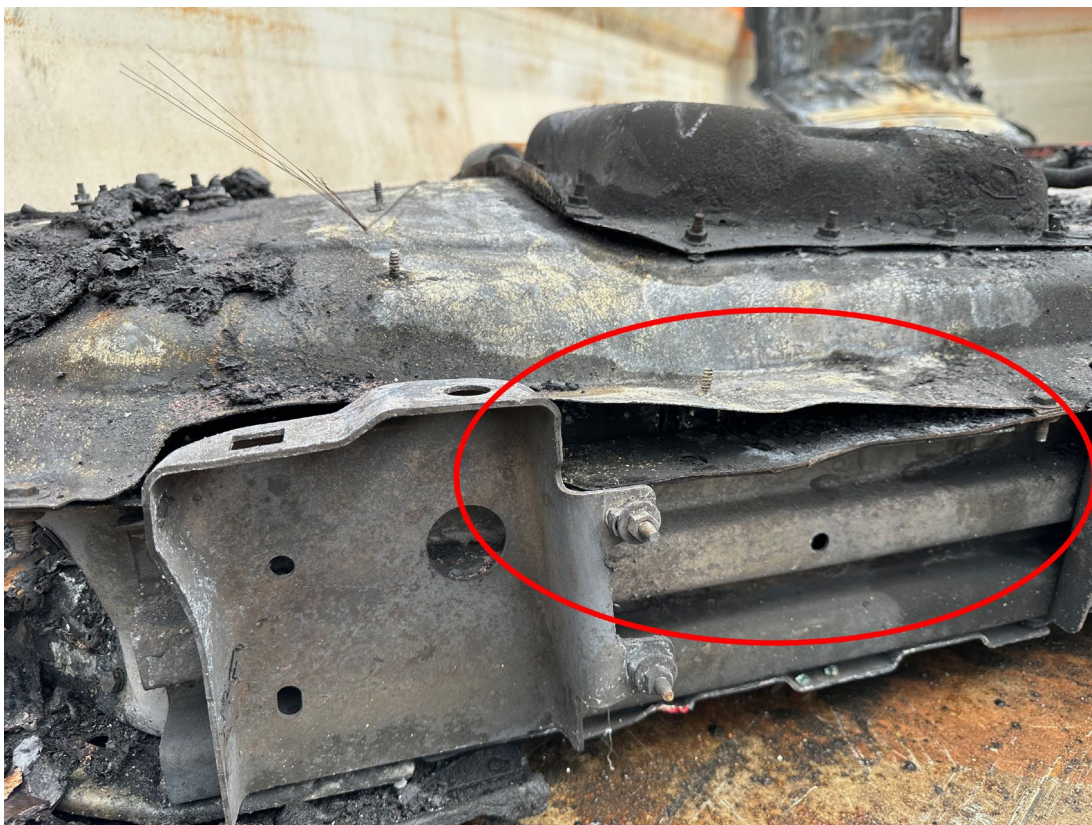
Figure 5.10 Opening on the side of the battery pack of approx. 4 cm

The top and bottom of the casing of the battery pack of this experiment also came loose and some damage occurred. The damage to the battery pack was greater in the second experiment than in the first. This can be explained by the fact that more jet fires and flames came out of the battery pack in the second experiment. The casing of this battery also had several openings of between 2 and 4 cm. An example is shown in Figure 5.10.

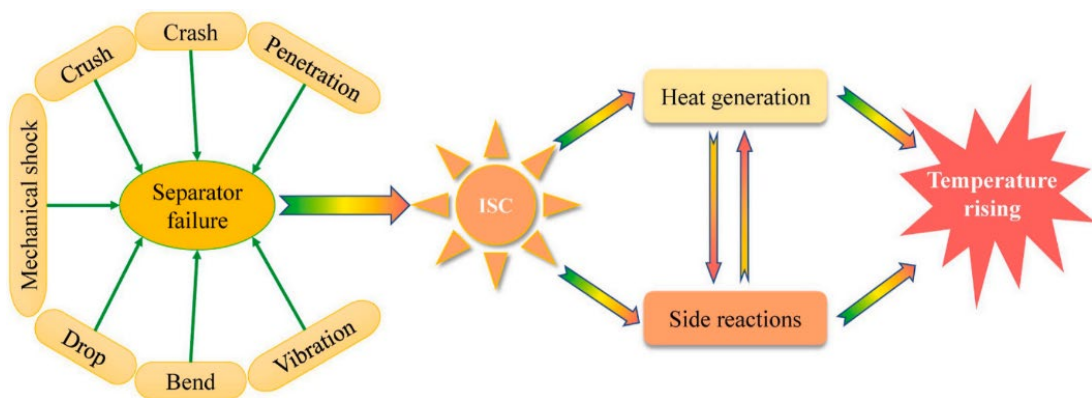
**Figure A1.2** Process after mechanically influencing the battery cell (Zhang et al. 2021)

Thermal runaway can be caused mechanically by fully penetrating one or more battery cells with a sharp steel rod (nail). Scientific literature also identifies this method as 'nail penetration'. To cause thermal runaway, the nail must penetrate the casing of both the battery pack and the modules and that of the battery cell. The location of the battery pack and, as a consequence, the need to penetrate the chassis and the bodywork must be taken into account. When penetrated by the nail, the separator in the battery cell creates a connection between the cathode and the electrode (Zhang et al. 2021). A current can flow through the nail, creating a current circuit at the penetration location. This leads to an ISC (Internal Short Circuit). The short circuit leads to heat being generated, causing other reactions to occur as well. The temperature in the battery cell will rise sharply, eventually leading to thermal runaway. This process is shown in Figure A1.2.

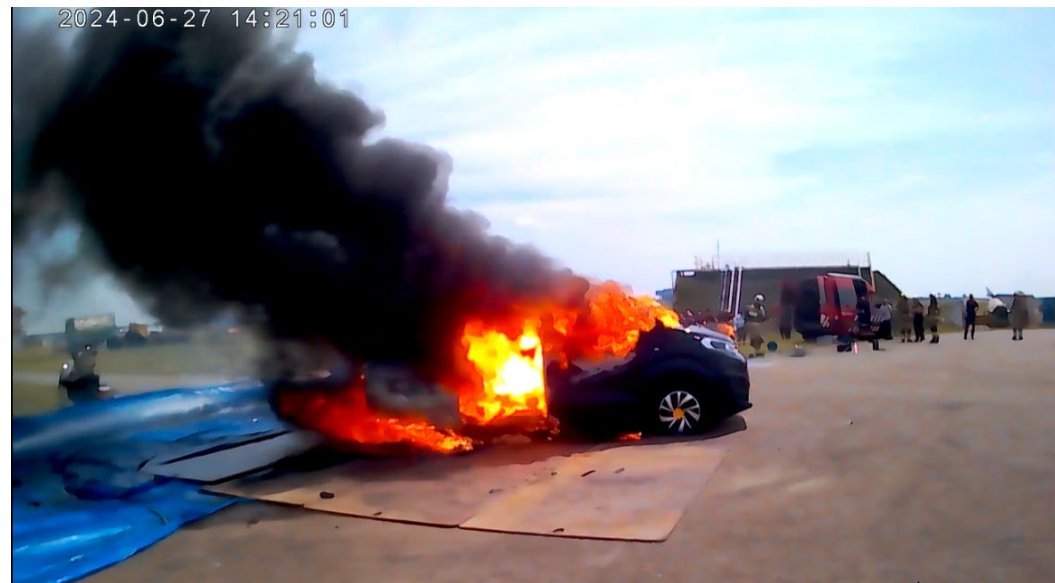
14:21 A bang was audible and at the same time sparks were visible from the battery pack.

The white ball of fire in the centre of the car is the result of the bang, resembling a minor explosion.
