## Summary of inspection report of fire along De Kelders in Leeuwarden, 19 October 2013

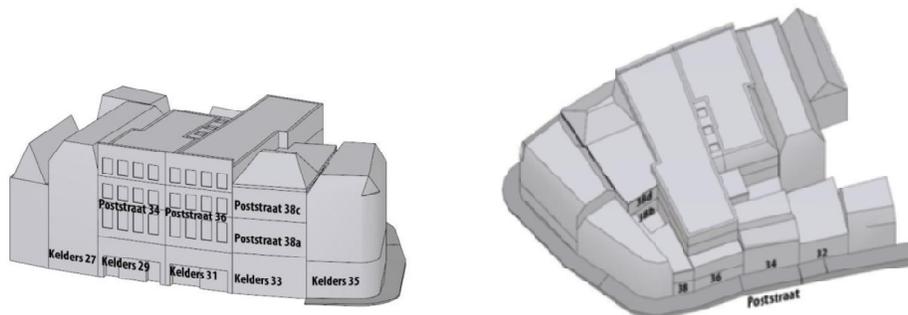
Illustration 1: Positioning of the premises and addresses in respect of each other (drawing: Tjalling Graafsma).
